**Re: Construction Damage Assessment – Supplemental Engineering Report**

File Name: Casey Slone  
Address: 303 North Washington Avenue, Marshall, Texas 75670  
Claim No.: W2C22131  
Reported Date of Damage: February 14, 2024  
J.S. Held No.: 240500935

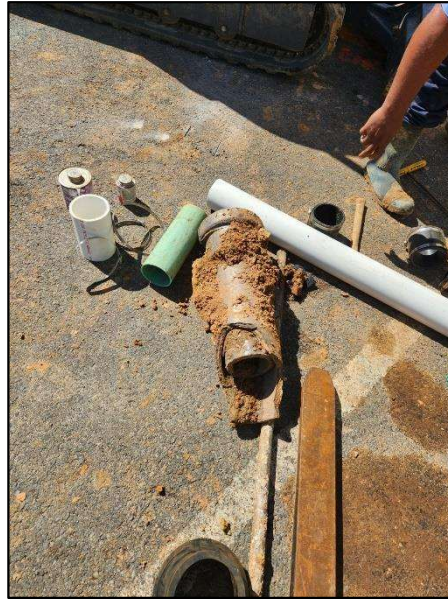
**Figure 1** – Smaller diameter pipe shoved into a larger diameter pipe at the break, as described in Mr. Slone’s and Mr. Powell’s emails.

Based on the location of the break with respect to the new storm drainage pipe, and without additional information to indicate otherwise, the correlational evidence seemed to indicate that the break in the sewer line and installation of the new stormwater drain were causally related. Further, the fracture in the sewer line, as depicted in Mr. Watts' photographs in J.S. Held's initial report, was still in situ and had not been separated out for better viewing. However, in the recently provided photograph of the condition removed from the earth, it could be clearly seen that a smaller pipe had been inserted into a larger pipe, which was the cause of distress, as described in the emails between Mr. Slone and Mr. Powell. Further, in those emails, Mr. Powell stated that the City had decided to repair the condition when it was exposed. As such, it appears that CSC did not damage the sanitary sewer line and that any such damage was repaired by the City.

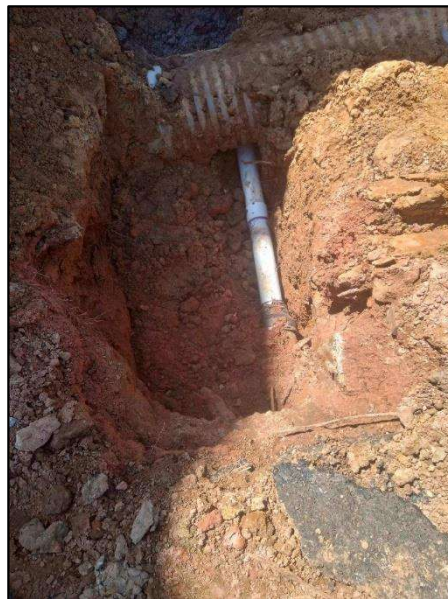
**Figure 2** – New polyvinyl (PVC) pipe tie into the sewer main.

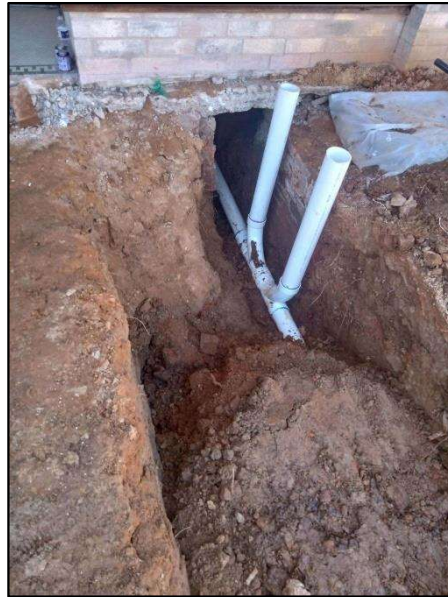
**Figure 3** – Continuation of the PVC pipe depicted in **Figure 2** into the crawlspace of Mr. Watts’ building. Note the cleanouts as described in Mr. Slone’s and Mr. Powell’s emails.

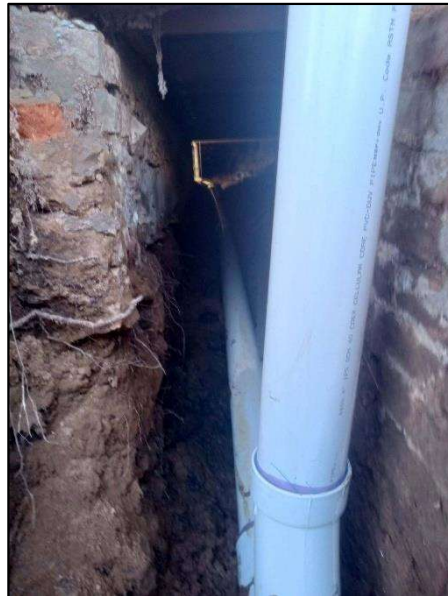
**Figure 4** – Continuation of the PVC pipe depicted in **Figures 2 and 3** into the crawlspace of Mr. Watts’ building. Note the cleanouts as described in Mr. Slone’s and Mr. Powell’s emails.
